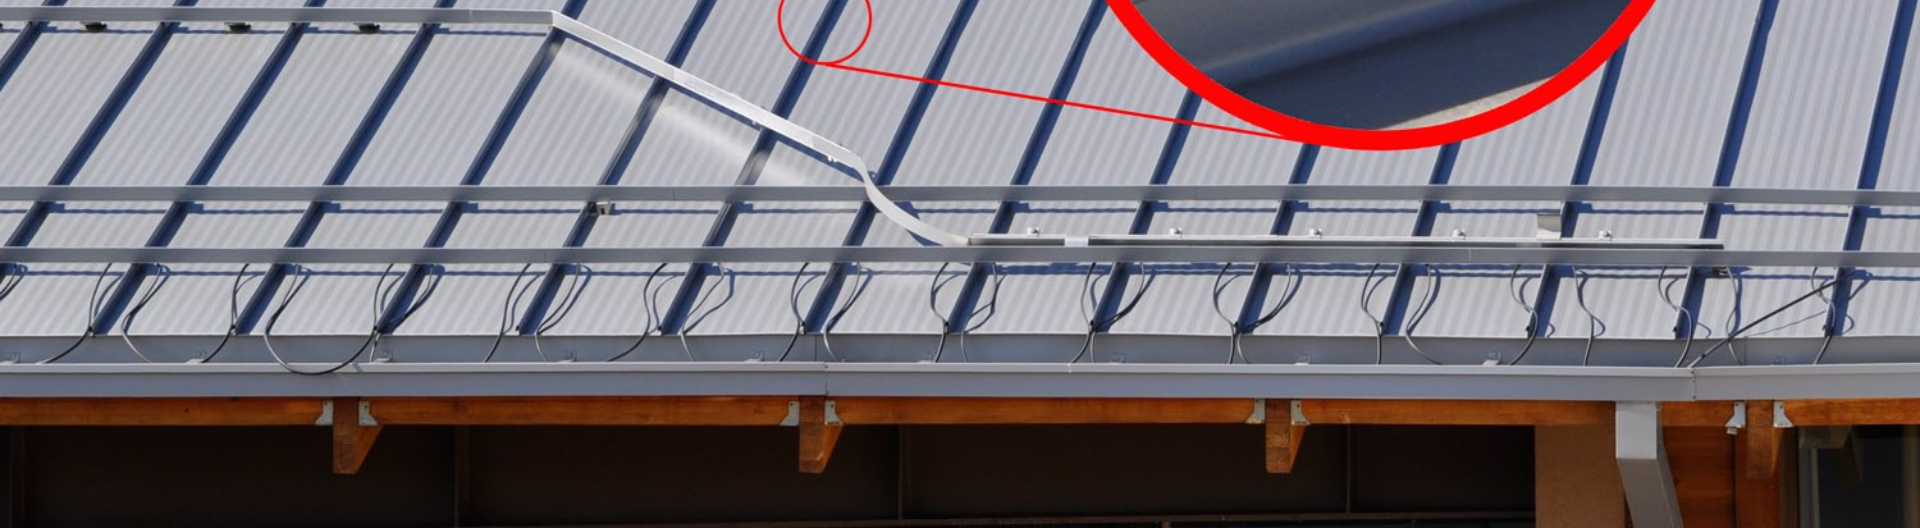
This illustration shows documented seam damage caused by improper installation of a bar system that utilizes round tip set screws.
